A Paired Watershed Approach to Evaluate Low Impact Development Practices on Stormwater Quality and Quantity

**Robert W. Nairn, Brandon Holzbauer-Schweitzer,
Noah Berg-Mattson and Michael Rice**

**Center for Restoration of Ecosystems and Watersheds
School of Civil Engineering and Environmental Science
The University of Oklahoma, Norman, OK**

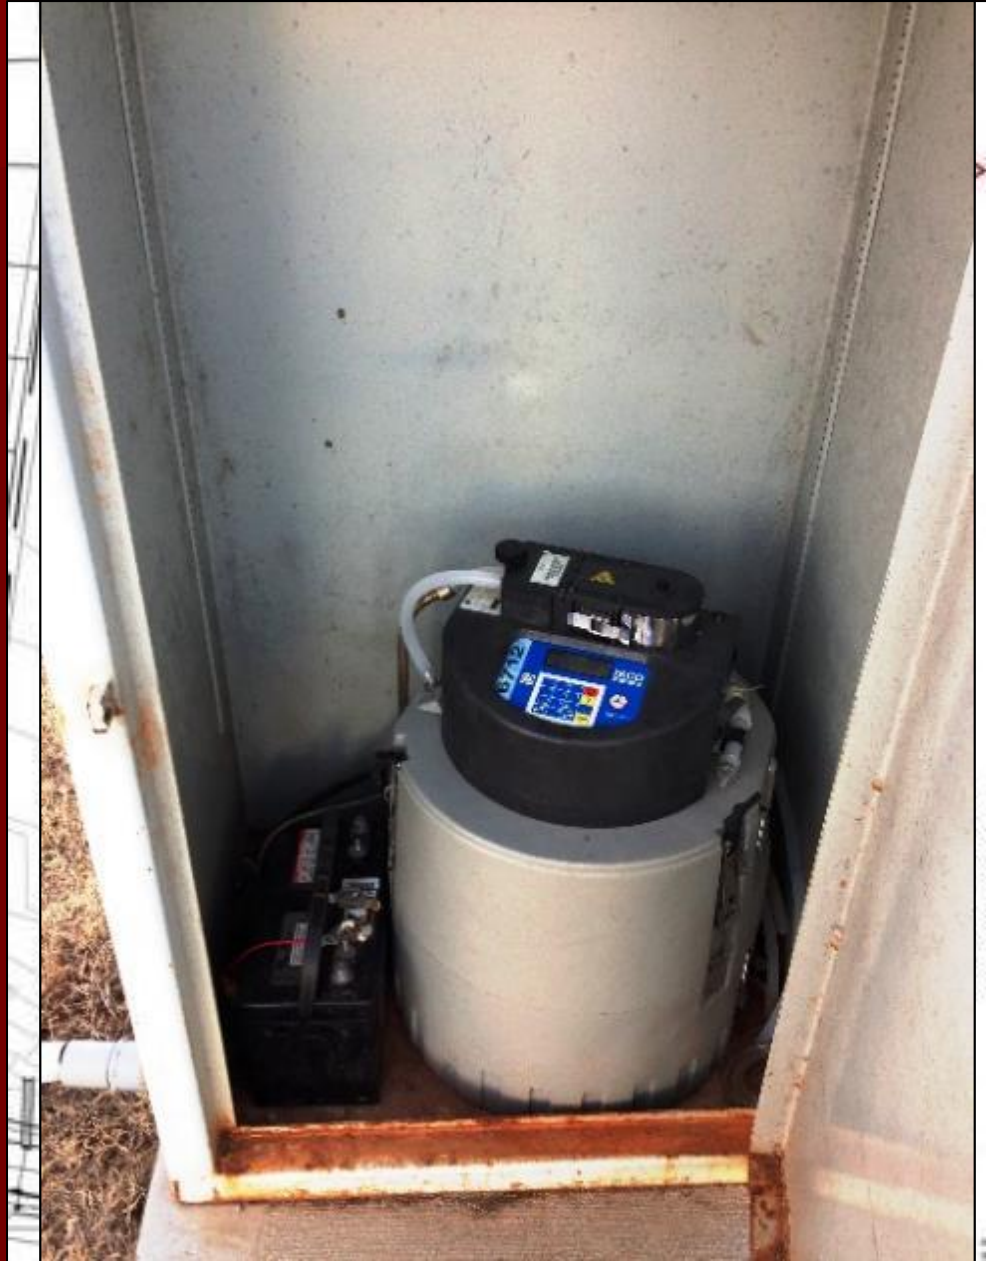
Data Collection

- Pre-fab FRP 18"x45° trapezoidal flumes
 - Accommodate Q_2 to Q_{100} storm events
- Automatic flow-activated samplers (Isco 6712 w/730 bubbler modules)
- Tipping bucket rain gauges

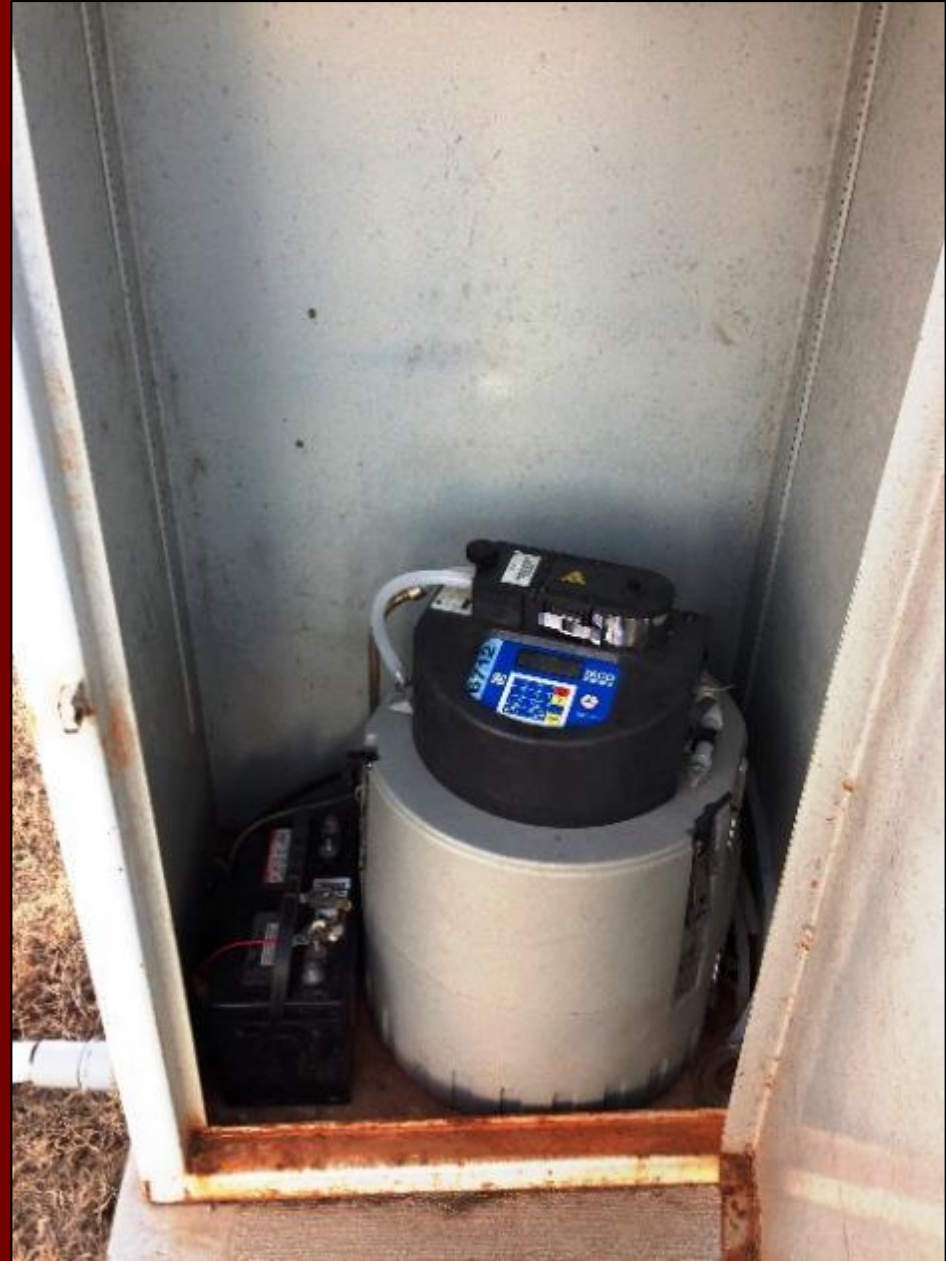
Data Collection

- Continuous Q measurement
- Sampling triggered at given depth
 - First flush
 - Composite storm

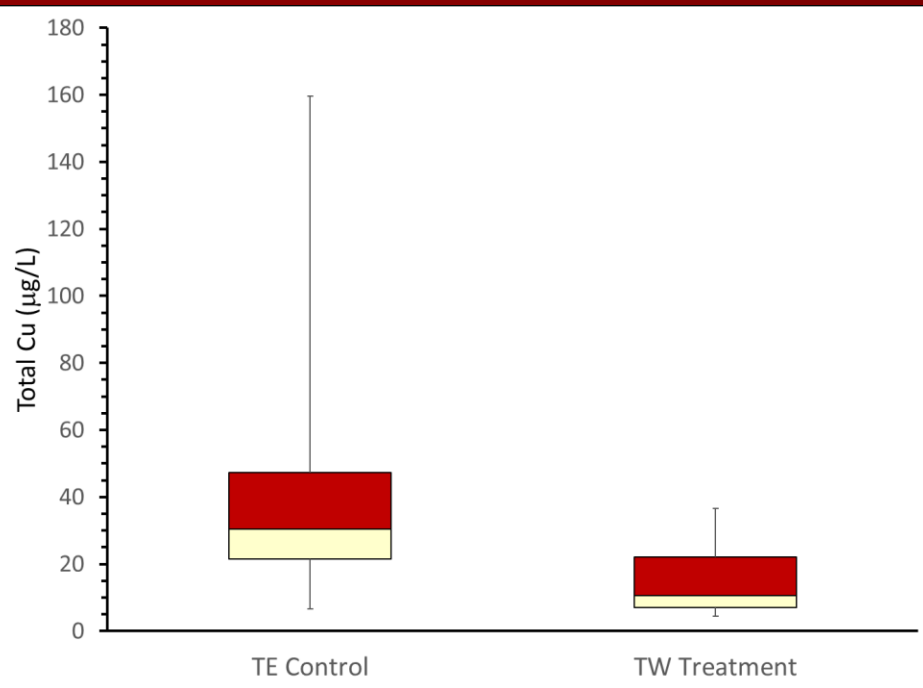
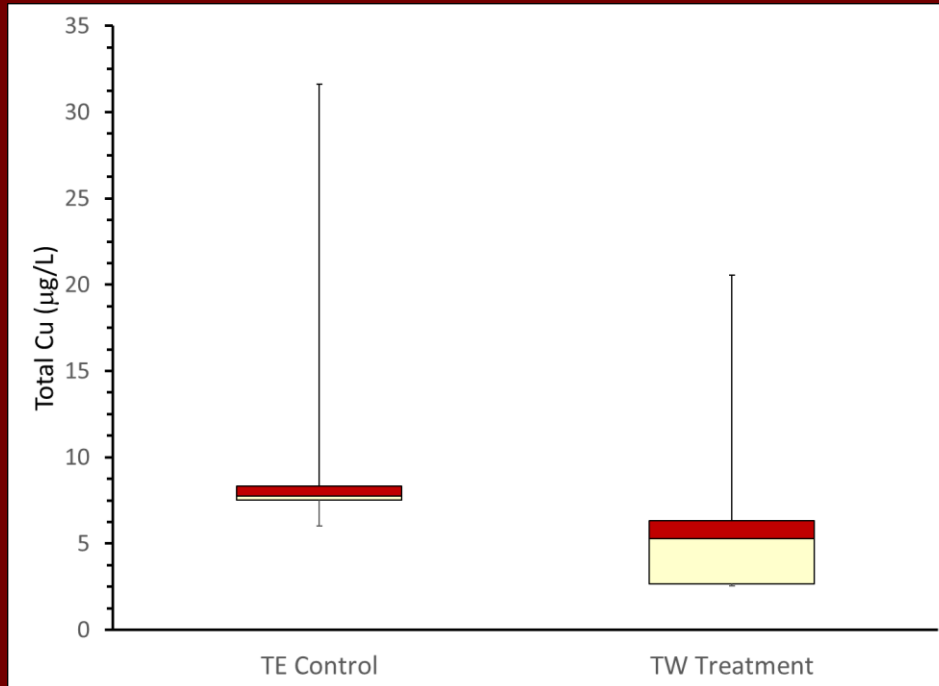
Total Copper

First Flush

Storm Composite

- Concentrations and mass loads (not presented) were generally lower exiting treatment watershed
 - Solids retained ($p < 0.10$) by LID BMPs
 - Increased retention times and redox conditions in rain gardens likely led to denitrification ($p < 0.10$)
 - Selected metals immobilized via sorption processes

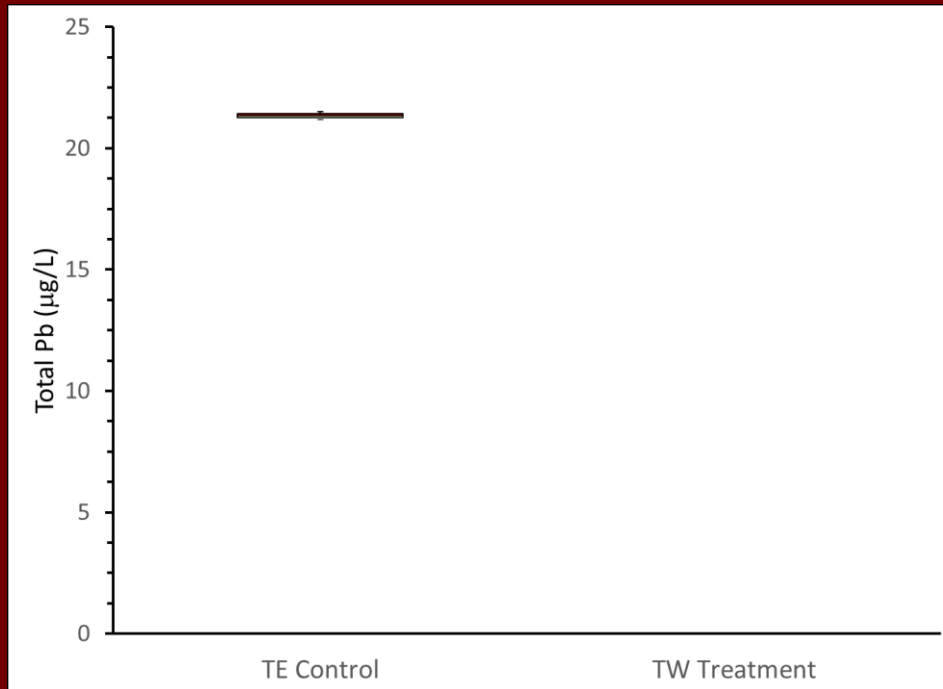
Total Lead

First Flush

Storm Composite

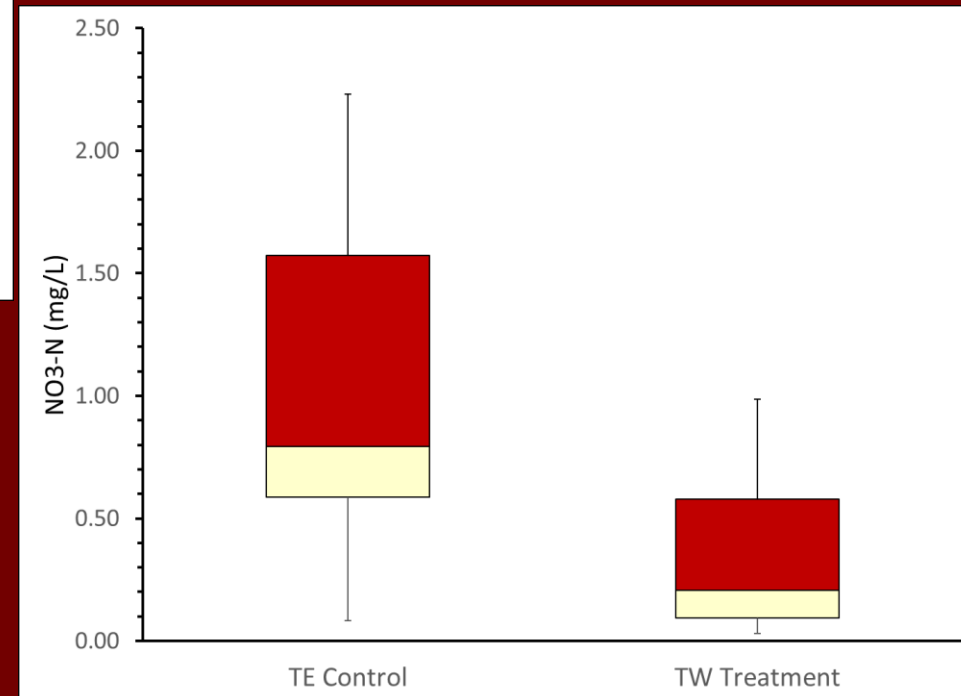
NO₃-N

First Flush

Storm Composite
