Tyner Creek Watershed Stream Stability Assessment

Reza Khakpour, PE, CFM & Russell Dutnell, Ph.D., P.E.

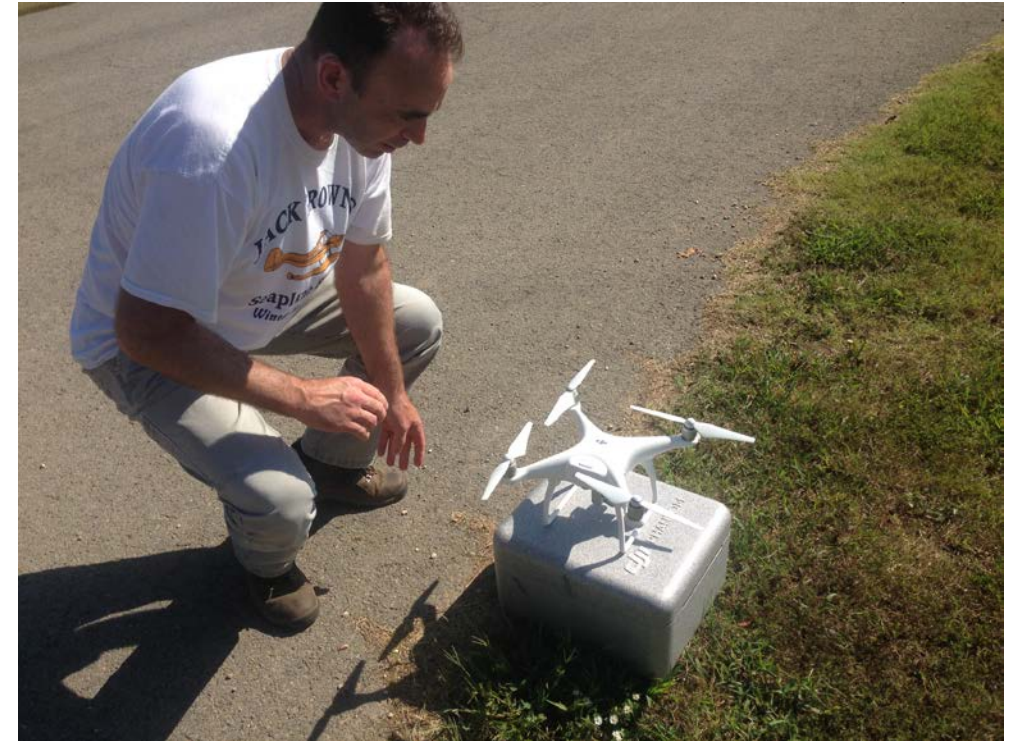
Task 2: Delineation of the assessment reaches

- The range of the drone is limited to approximately 1½ miles
- 14 “launch sites” were required to cover the channels identified in Task 1.
- The image shows the 14 reaches flown from these “launch sites”.
- 71 snap shots were taken at “sites of concern”.

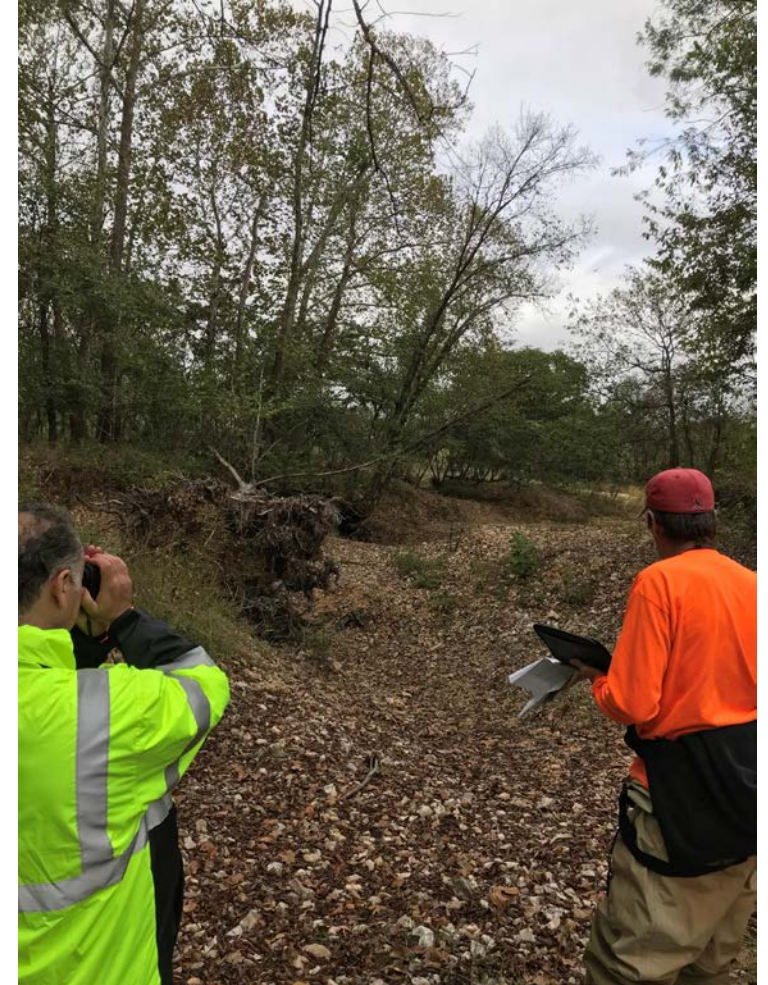
Site 6

Task 4: Field assessment of Tyner Creek assessment sites

Assessment Site Descriptions

Site Location:

Geographical:

Latitude: 36.03317^o; Longitude: -94.71120^o

UTM Oklahoma (South Plane):

Easting: 2940723.45'; Northing: 392560.74'

Reach Length: ~630 yards

Est. Project Cost: ~\$1,234,000

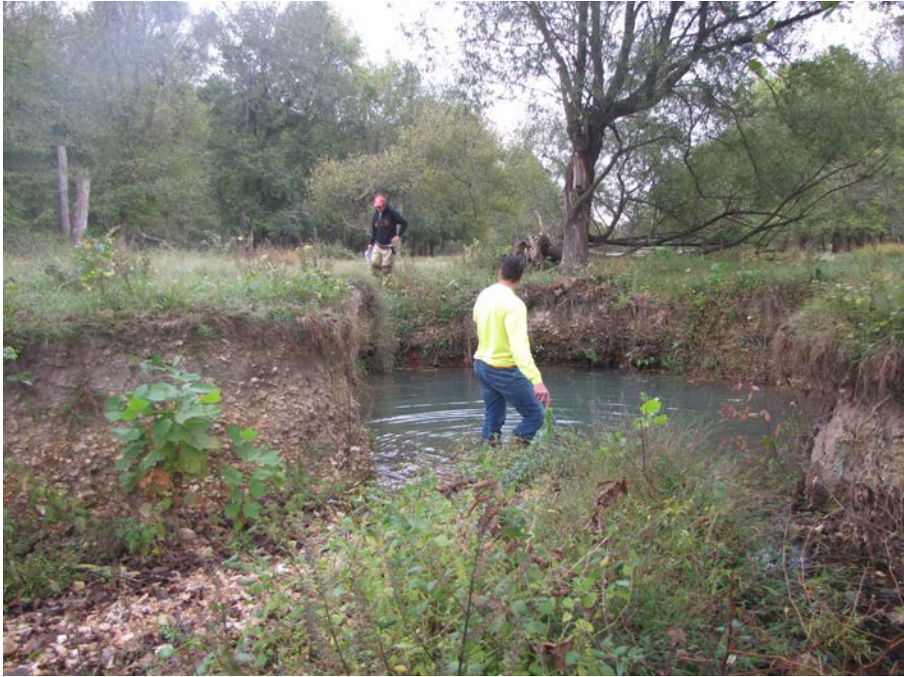
Estimated sediment load reduction

- Reduced sediment loading is one of the primary benefits of natural channel rehabilitation; so much so, in fact, that even though it was not listed as a project task, estimates of the sediment load reduction that would be provided by implementation of a project at each site were included in the assessment.
- This was accomplished using aerial photography from 2008 and 2015, and two different but similar methods.
- In one method, the product of the field measured bank lengths and heights were multiplied by the average bank erosion distance observed in the aerial imagery.
- In the other method, the bank height measured in the field was multiplied by the area of the bank eroded as observed in the aerial imagery.
- The estimates provided by the two methods are similar.
