# Temporal and spatial variability of limnological properties in a central Oklahoma reservoir: observations from a first year of sampling

By Jonathan West, Zach McKinney, and Julie Chambers

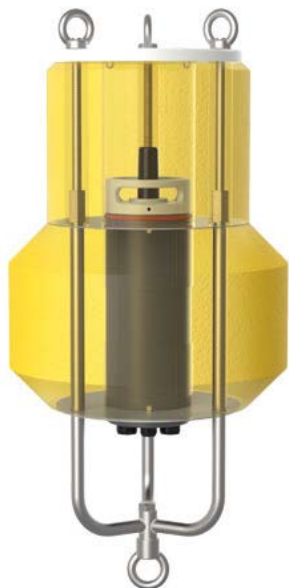
Multi-parameter  
instrument in data buoy

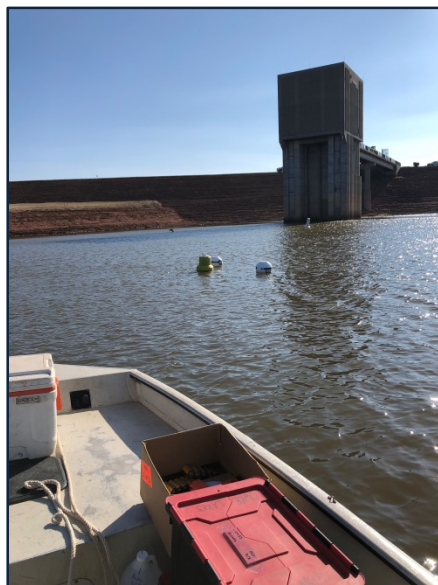
Temperature String

0.5 – 11.5 m
