Long-term turbidity patterns at Lake Wister...

Steve Patterson

OCLWA April 13, 2012

...and their implications for restoration and management

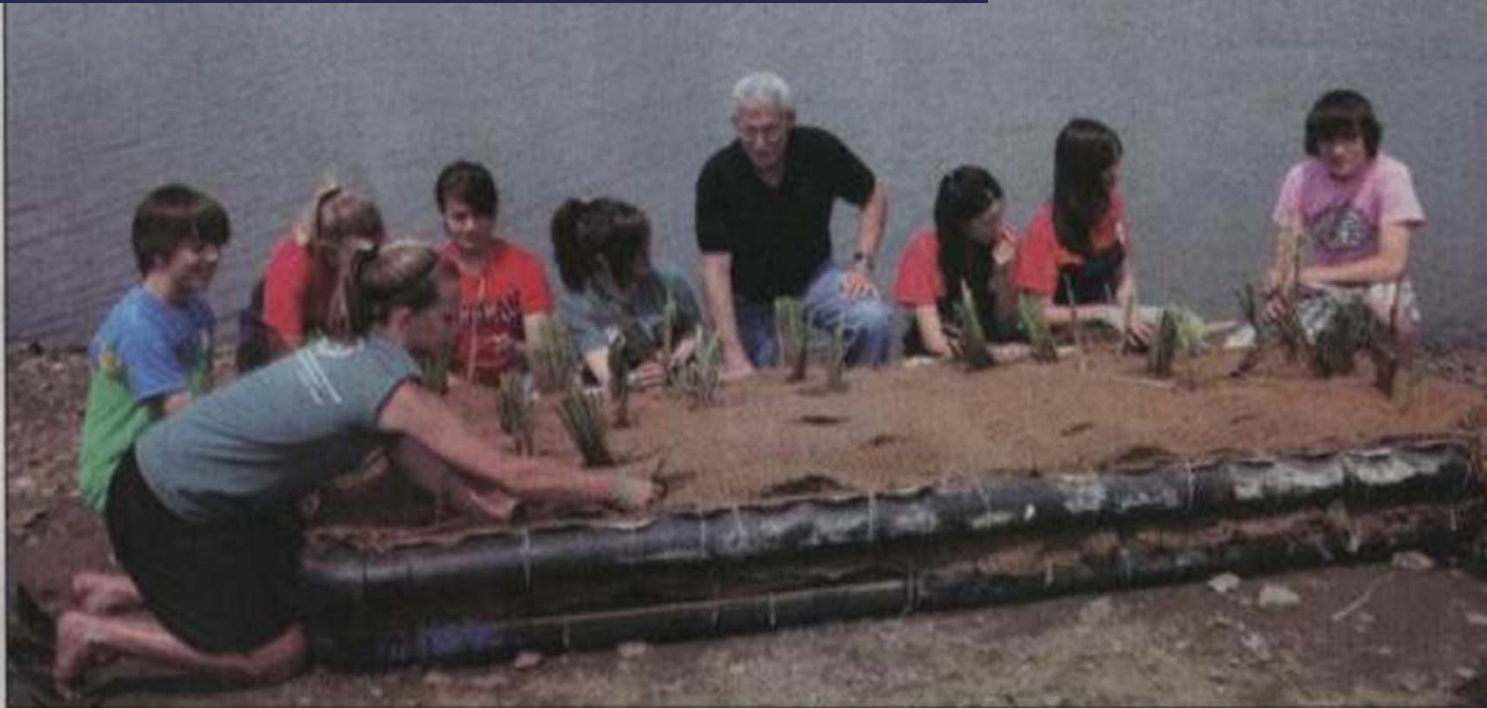
Ken Hammond, center, chairman of Poteau Valley Improvement Authority, helps area students prepare floating rafts Wednesday at Wister Lake. The rafts are designed to absorb harmful nutrients and phosphates from the water. The event was hosted by Choctaw Nation of Oklahoma and Poteau Valley Improvement Authority in an effort to clean up Lake Wister.
