# Proactive Landscape Design Addressing Water Quality in Lake Thunderbird Watershed

Trail Woods Subdivision Norman, OK

Division of Landscape Architecture  
Dr. Reid Coffman, Kent State University  
Graduate Assistant: Bryce Frost, OU

School of Civil Engineering & Environmental Science  
Dr. Bob Nairn, OU  
Graduate Assistant: Michael Rice, OU

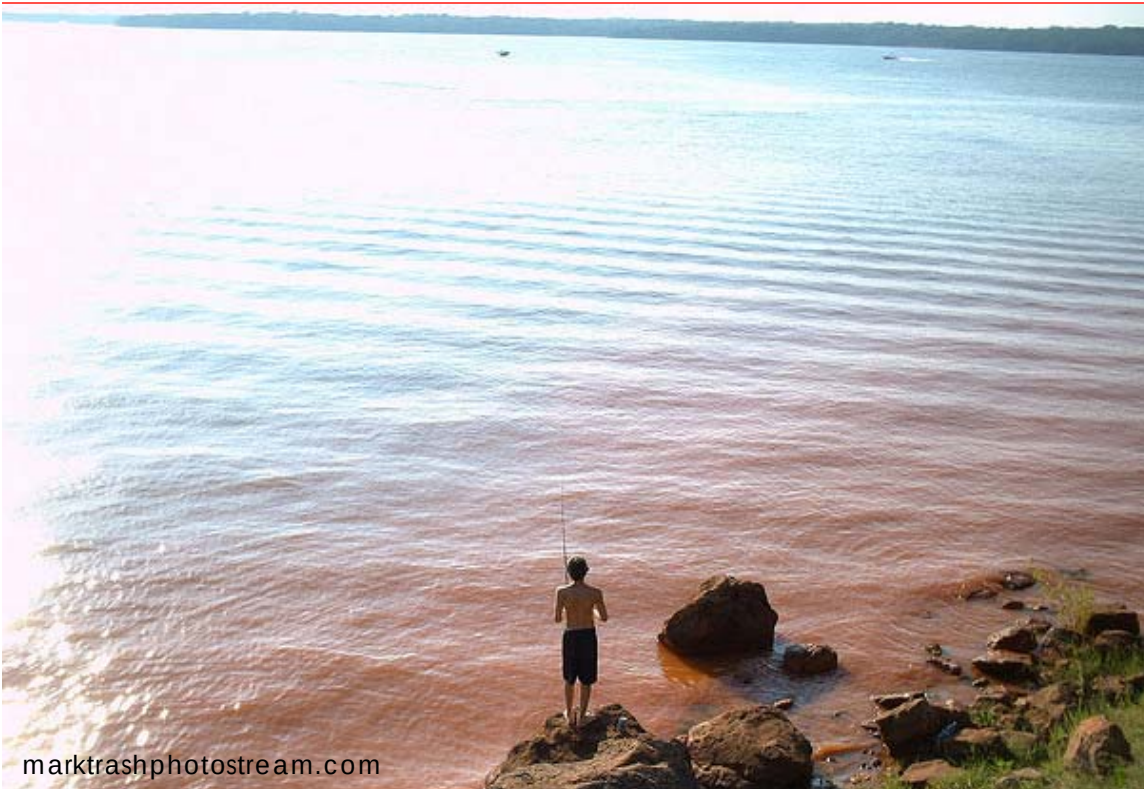
# Site Context / The Problem

- **Lake Thunderbird - Sensitive Water Supply but not supporting designated uses**
  - Turbidity
  - Low dissolved oxygen
  - Color
  - Chlorophyll-a
  - Taste and odor
- Due to urban expansion

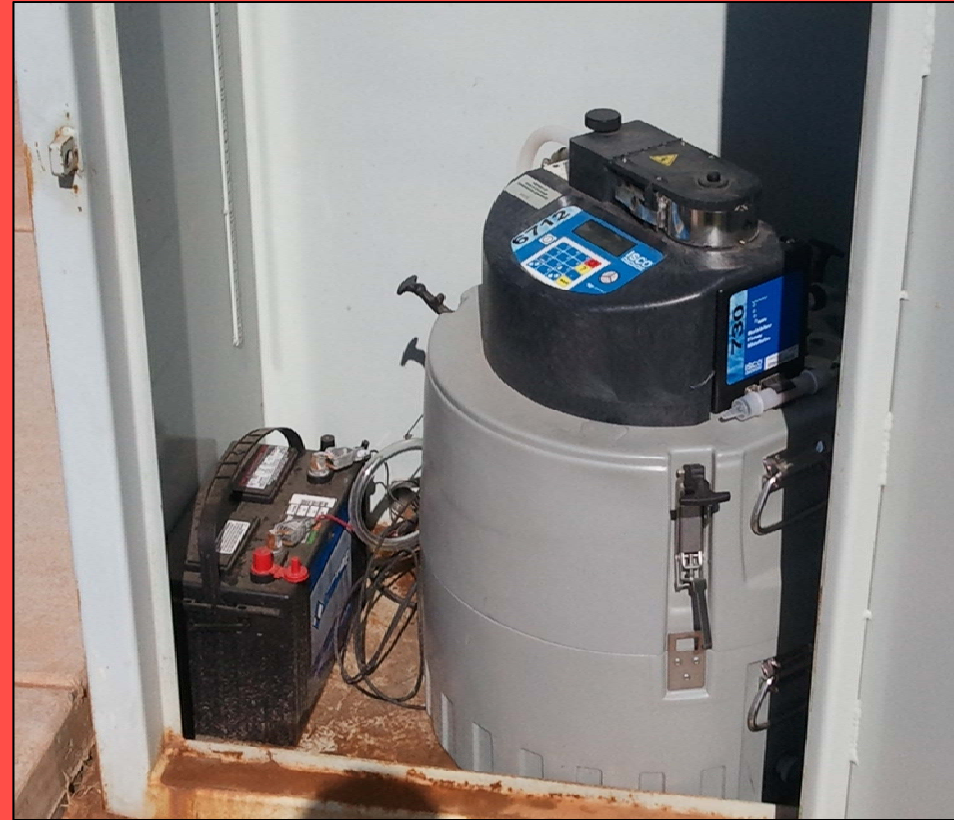
# Monitoring Stations

## ***Trapezoidal Flumes***

- two 18" 45° pre-fabricated trapezoidal flumes
- include both bubbler (quantity) and sampler (quality) connections

## ***Automatic Samplers***

- depth-activated
- composite “first flush” samplers

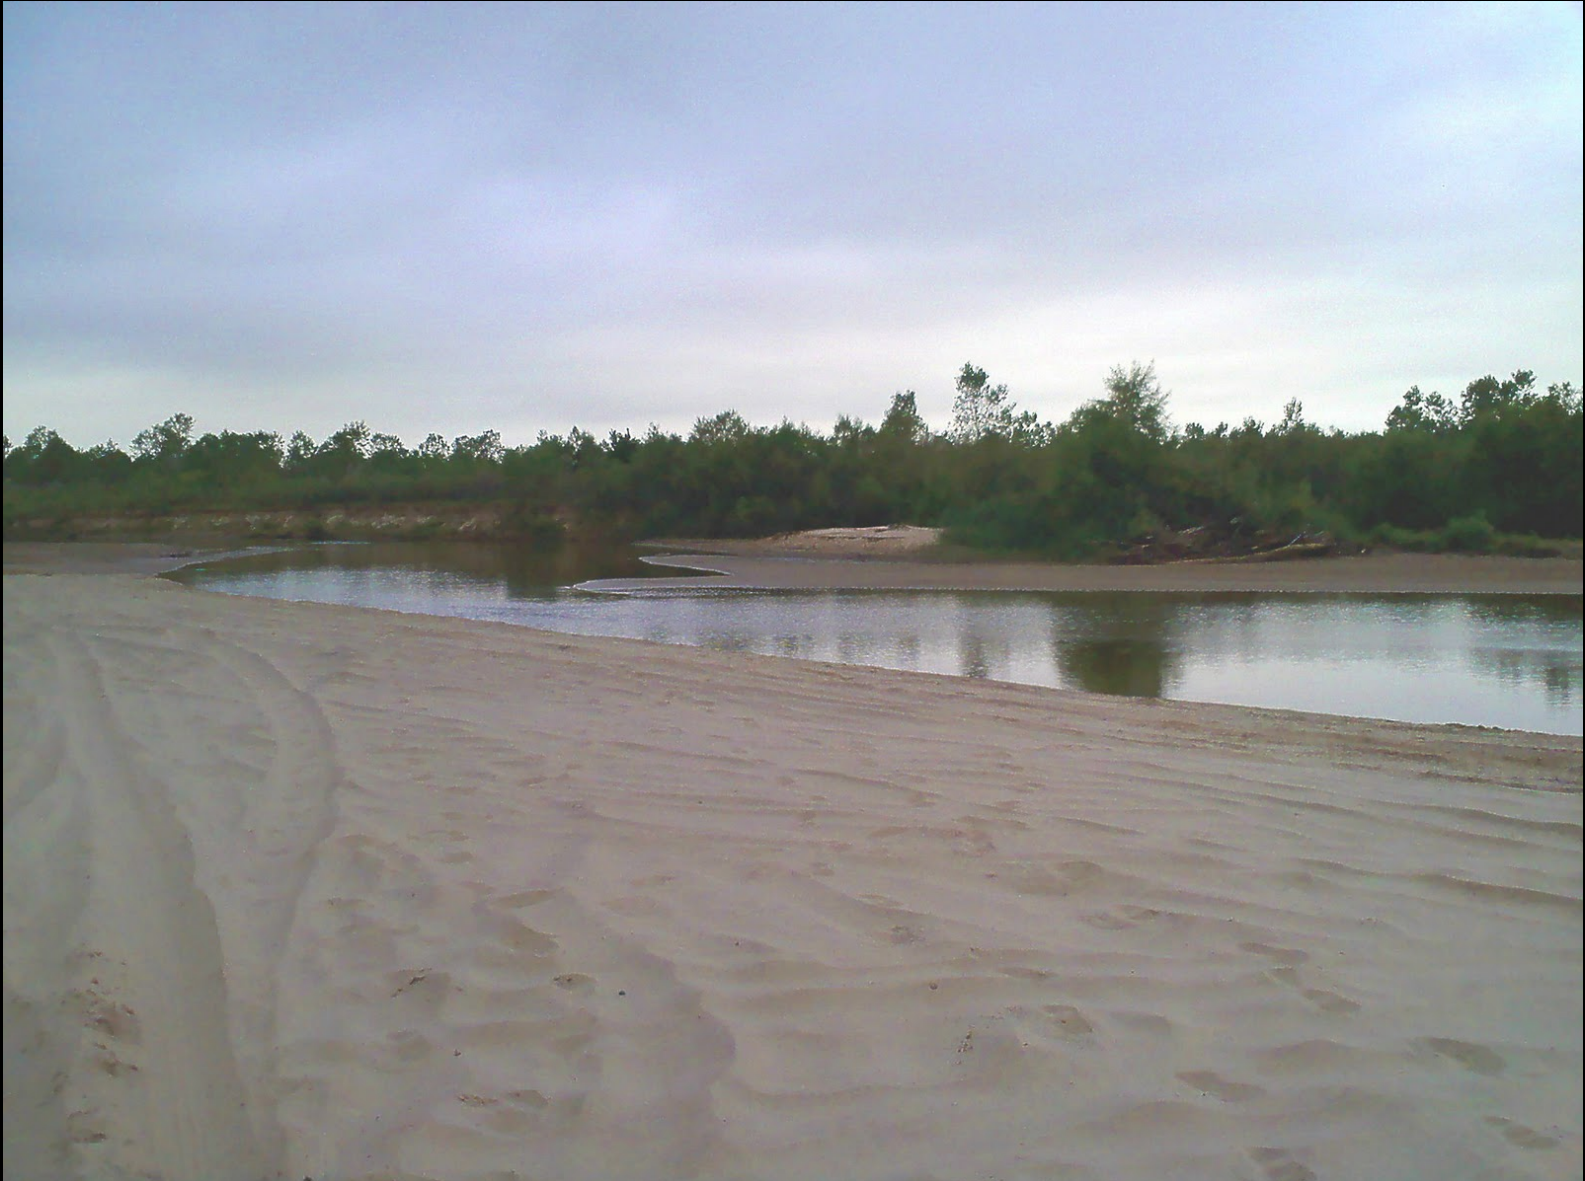
# Results to Date

- Near completion of all houses
- One remaining garden to install
- Monitoring site setup near completion
- No viable storm event samples been collected
- Homeowners need educated
- Successful plants / replanting
